# Hydrogeologic Controls and Impacts of Quaternary Landslides Along the White Bluffs of the Columbia River, South-Central Washington

Bruce N. Bjornstad  
and  
Robert E. Peterson

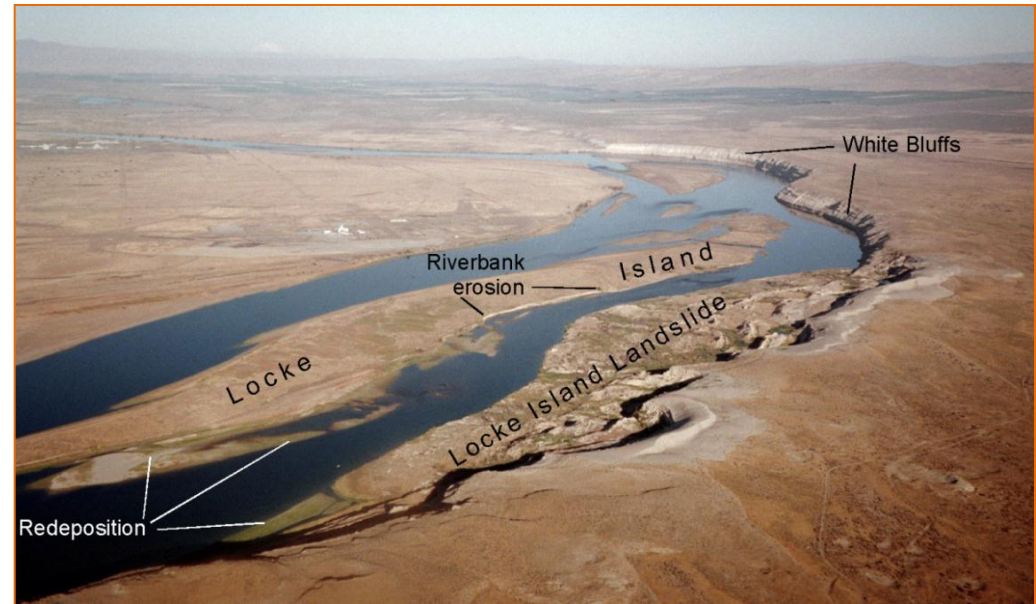
# Adverse Effects at Locke Island

- ▶ Riverbank erosion (up to 42 m since 1994), especially during peak flows of Columbia R.
- ▶ Destruction of sensitive cultural resources
- ▶ Downriver siltation of salmon-spawning areas

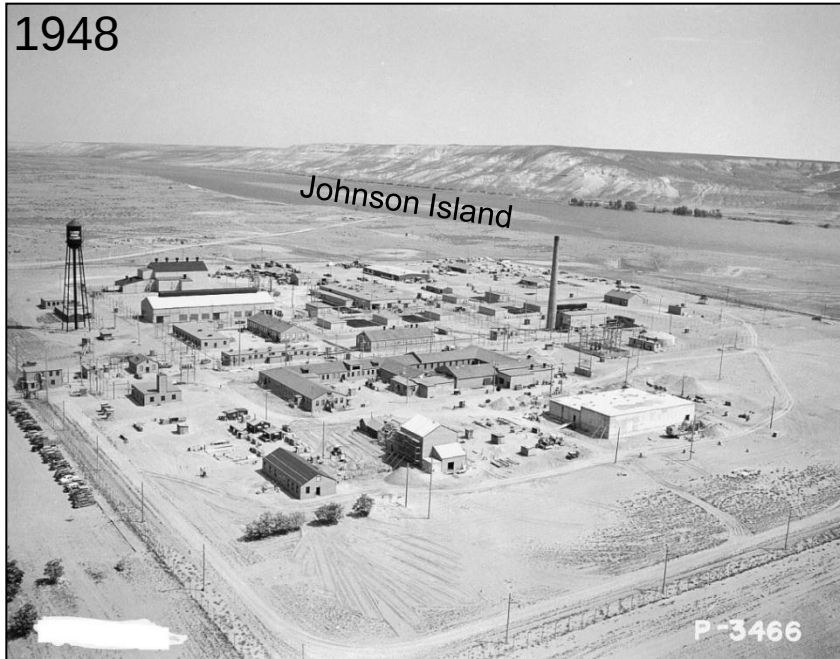
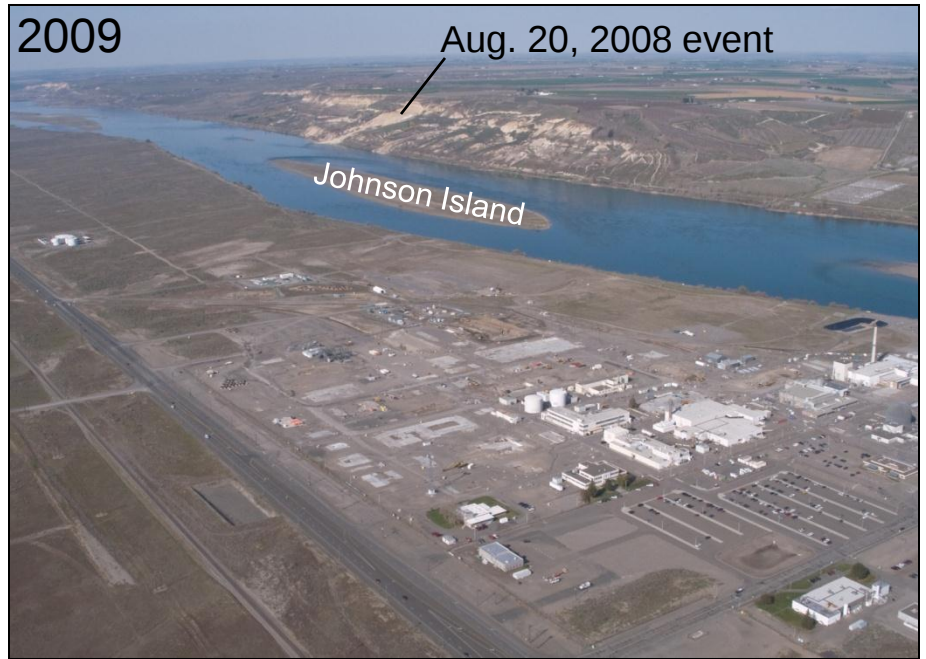
# Johnson Island Landslide Complex- Then and Now

View looking northeast over the Hanford-Site 300 Area

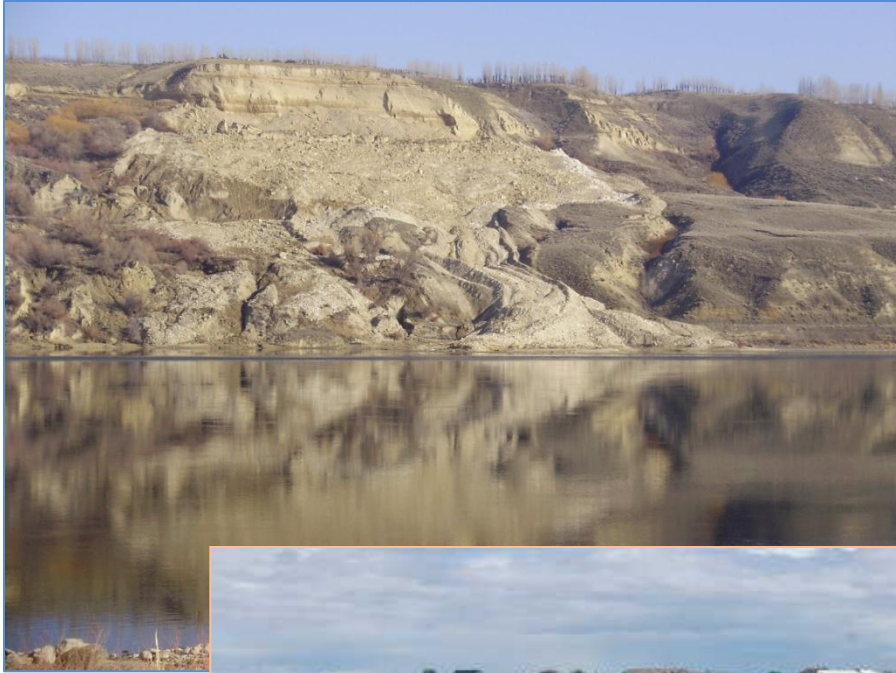
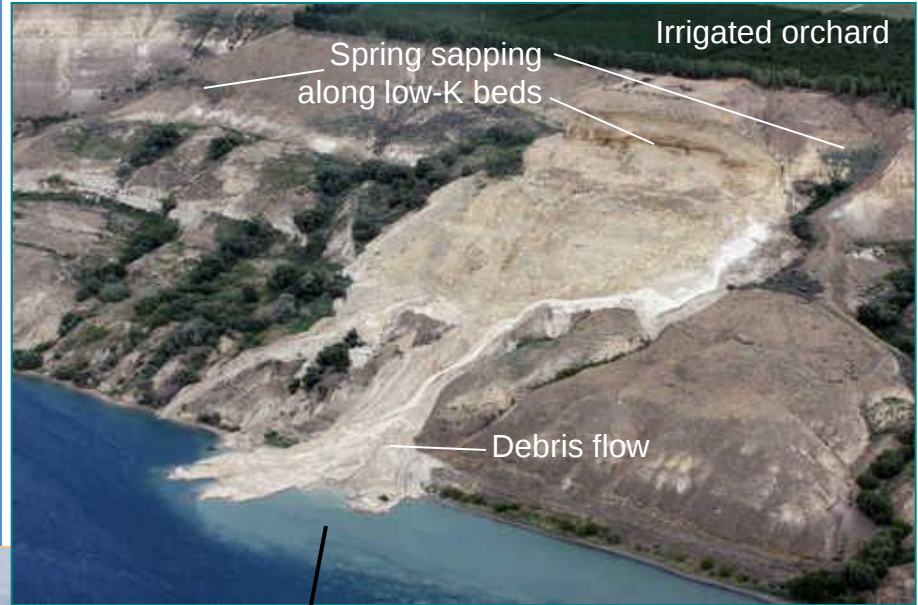
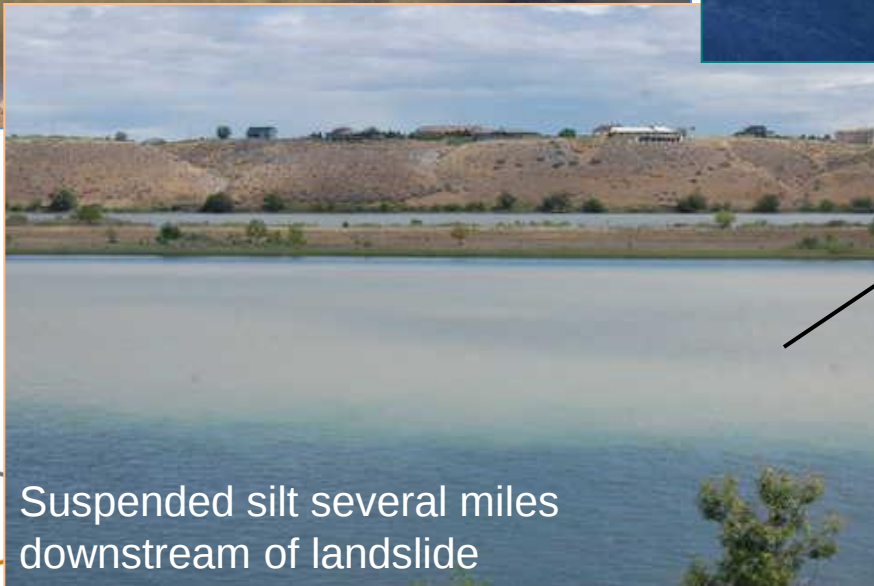
# Recent Landslide Events: Johnson Island – August 20, 2008

Silt plume

Suspended silt several miles  
downstream of landslide

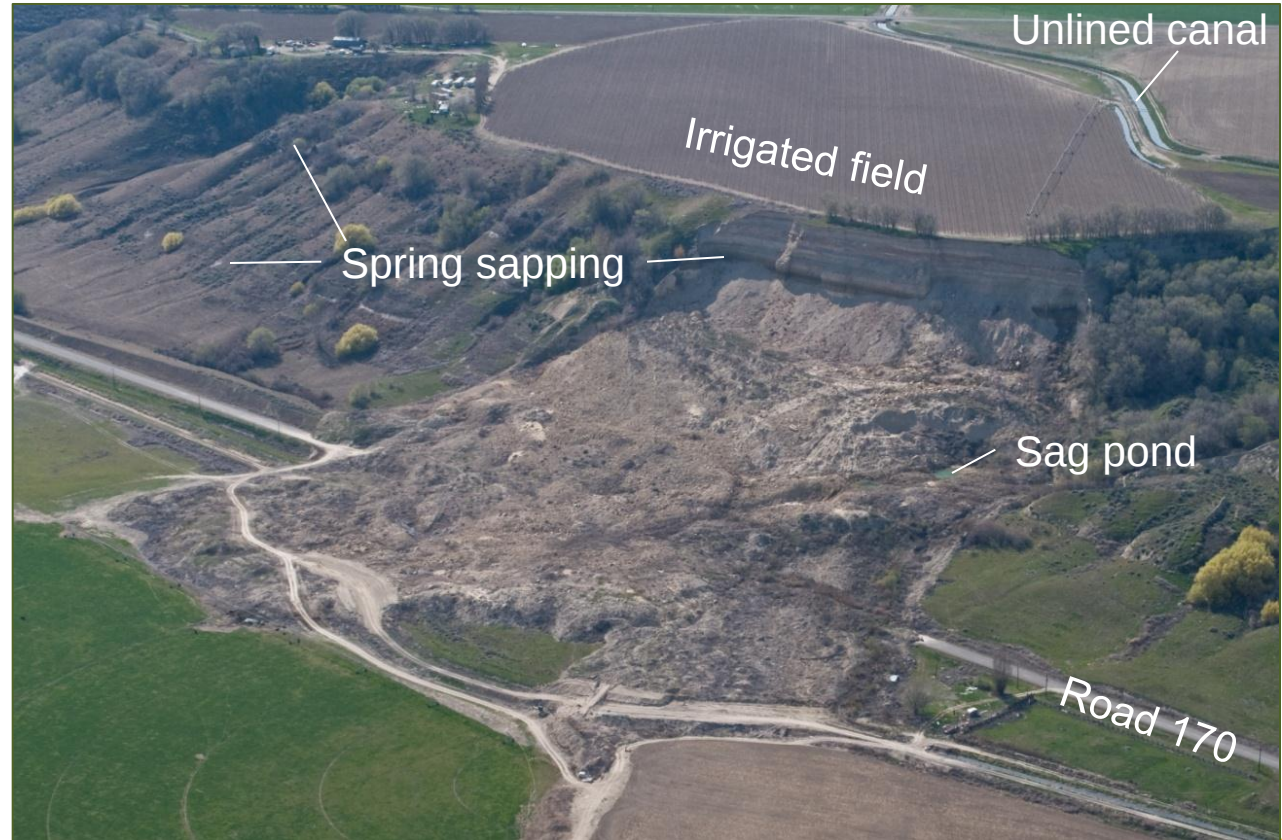
# Basin Hill Event, May 13, 2006

- ▶ Most of the slump failed and moved in a single evening
- ▶ A busy county road, an irrigation canal, and acres of productive farmland were buried beneath landslide debris
- ▶ Farm worker's home almost wiped out
